Field Report for Airborne Data Collected In Support of US EPA Region 6 South 4 Group Fire 07 December 2019

Flight Results for Flight 19, 07 December 2019

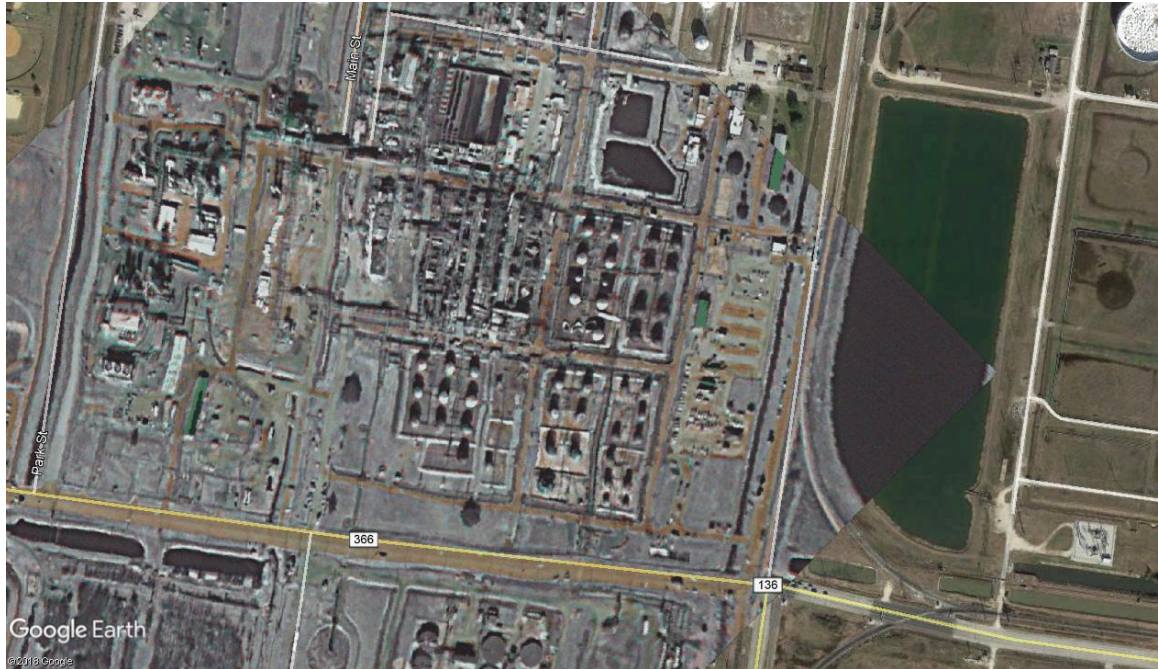
A total of 1 test and 9 data collection passes were made in the proximity of the facility and an infrared line scanner image was generated for each pass. Figure 3 shows a typical 3-band infrared image obtained from data collected for Run 5. The image shows a flat thermal environment for the process unit other than heating due to solar radiation. No plume is present in the image. To assess possible oil sheen presence on the Naches River and a nearby drainage channel, ASPECT collected IR data along the drainage waterways; no oil sheen signatures were detected (figures 4 and 5).

Figure 3: – 3 band IR image, Flight 19, Run 5, South 4 Group Fire

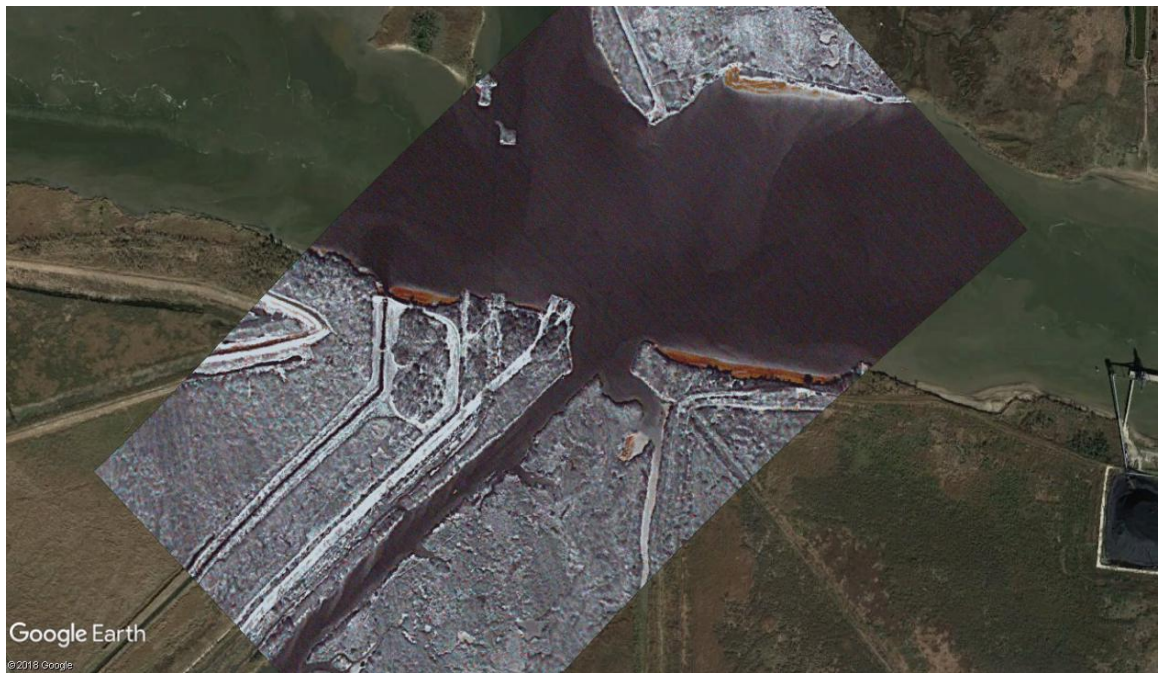
Figure 4: -- 3 band IR Image, Flight 19, Run 9, South 4 Group Naches River Confluence

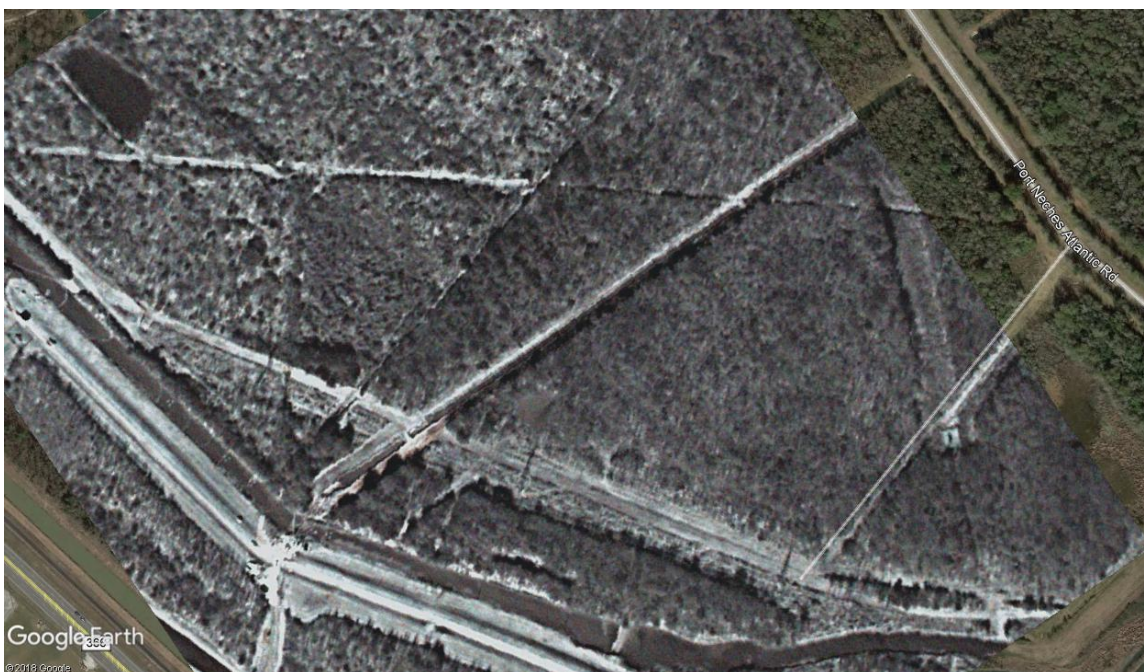
Figure 5: -- 3 band IR Image, Flight 19, Run 10, South 4 Group Waterway Image

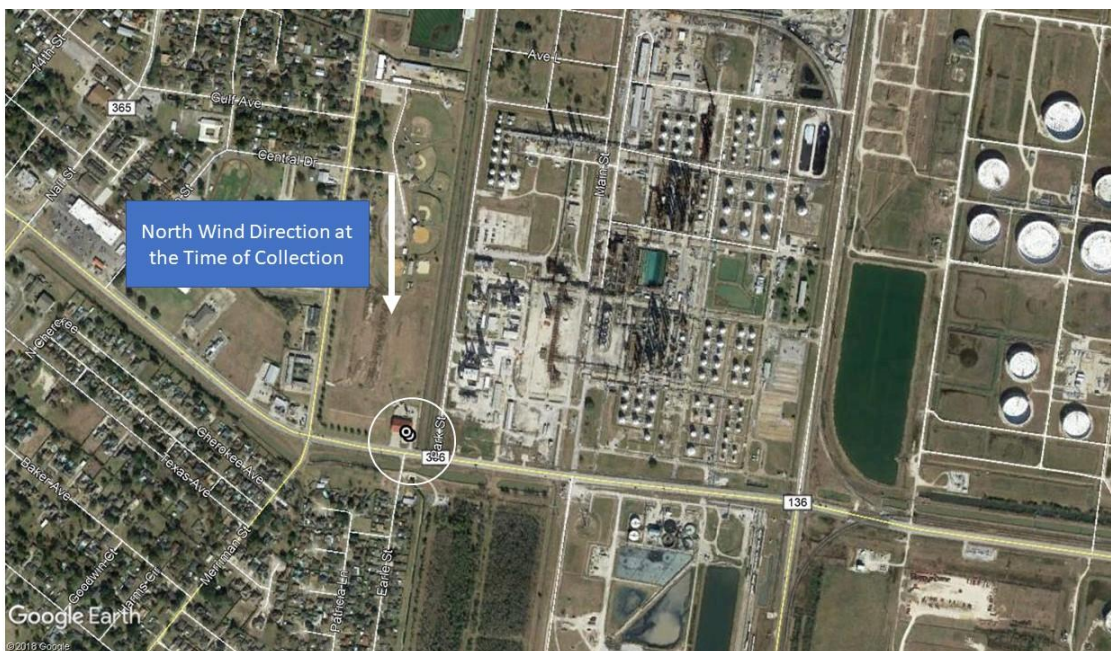
On data collection Run 3, isobutylene was detected at a maximum concentration of 1.63 ppm about 550 meters Southwest of the facility (figure 6). At the time of collection, winds were from the North. To further assess this detection, a line was flown between Run 2 and Run 3 which showed no detections. The wind direction during this collection was also from the north. A summary of data of the data collection is given in table 3.

Figure 6: -- Isobutylene Detection, Flight 19, Run 3, South 4 Group Waterway Image

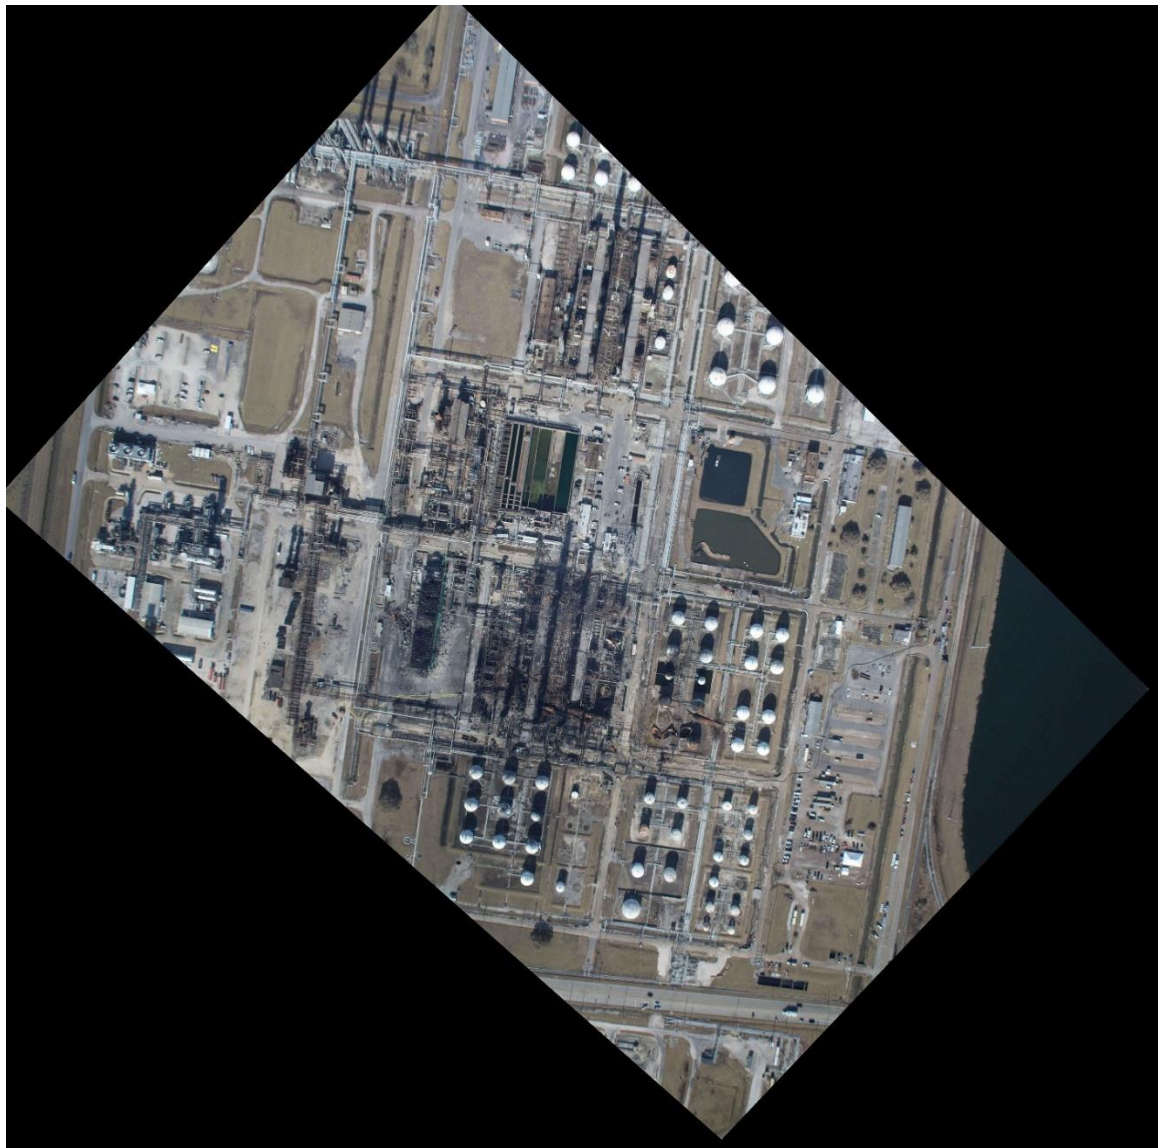
Figure 6: Aerial Image, Flight 19 South 4 Group Fire.

A full set of high resolution aerial digital photography were collected as part of the flight. Figure 7 and 8 show representative views of the process unit. No emissions are visible in these images. In addition, the images and crew reports indicated that no water cannon was in use.
